# The Locomotive

THE HARTFORD STEAM BOILER  
INSPECTION AND INSURANCE CO.

**VOL. XXXVIII**

HARTFORD, CONN.  
1930-1931

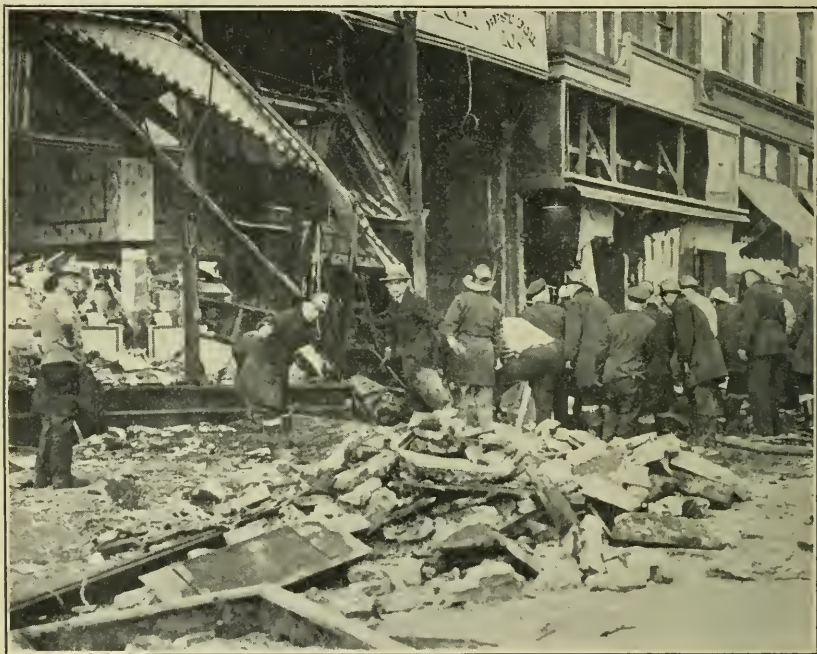
Figure 1

FIVE persons were killed and forty others were injured in Washington, D. C. when, on November 22, an exploding hot water supply tank ripped its way up through a sidewalk and into a dense crowd of Christmas shoppers. The blast was so severe that it

The exploded vessel was a vertical tank six feet long, 37" in diameter, and welded throughout. Its shell was of 3/16" steel plate and both heads were of quarter-inch material. It appears that the bottom head had a flange or skirt and was fitted inside the shell so that it had a "minus" dish and that excessive pressure turned this head inside out (see Figure 2) and tore it loose from the shell at the welded joint. The top head was of somewhat different construction. It was without a flange and was installed so that it bumped outwardly, resembling a large, shallow saucer with its rim welded to the end of the shell plate.

According to an official report by one of the city's assistant engineering commissioners, the tank was equipped with a safety valve set to relieve at 65 pounds. This valve was found to be in good condition when tested after the accident, the commissioner venturing the surmise that its failure to prevent over-pressure may have been caused by an obstruction of some sort in the pipe between the valve and boiler.

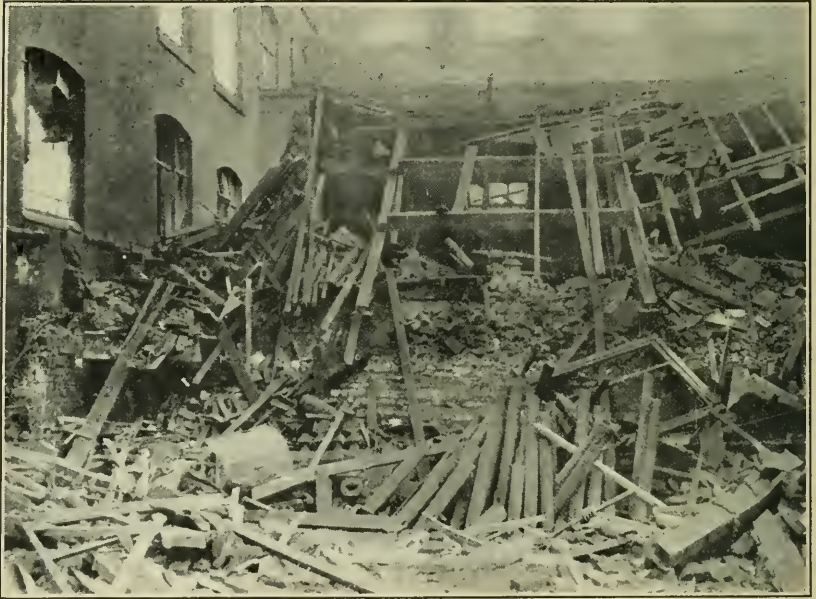
**F**AULTY manipulation of the dampers and feed line valves on an economizer of the ordinary cast iron type recently caused a very serious explosion that not only destroyed the apparatus itself but wrecked the building housing it. The accompanying illustration is a photograph of the wreckage.

and there was no chance for a circulation of water through it, the hot flue gases started to generate steam which overheated the metal and probably caused serious expansion stresses at the joints between the tubes and the upper header. The explosion occurred about half an hour after the fires were stirred up. It is suspected that even though the gases were by-passed around the economizer during the night, there may have been enough leakage past the damper to keep the tubes fairly hot, so that steam was quick in forming after the full supply of flue gas was shunted through the apparatus.

An examination of the fractured tubes showed that many of them had been affected internally by graphitic deterioration. Wall thickness

was generally well maintained but at some points the greater part of the cast iron seemed to have been converted into a graphitic structure. At places this graphite had broken away from the tubes, leaving a very much reduced thickness of good cast iron. Undoubtedly, this change in the nature of the material had taken place over a long period, for the economizer was twenty-five years old.

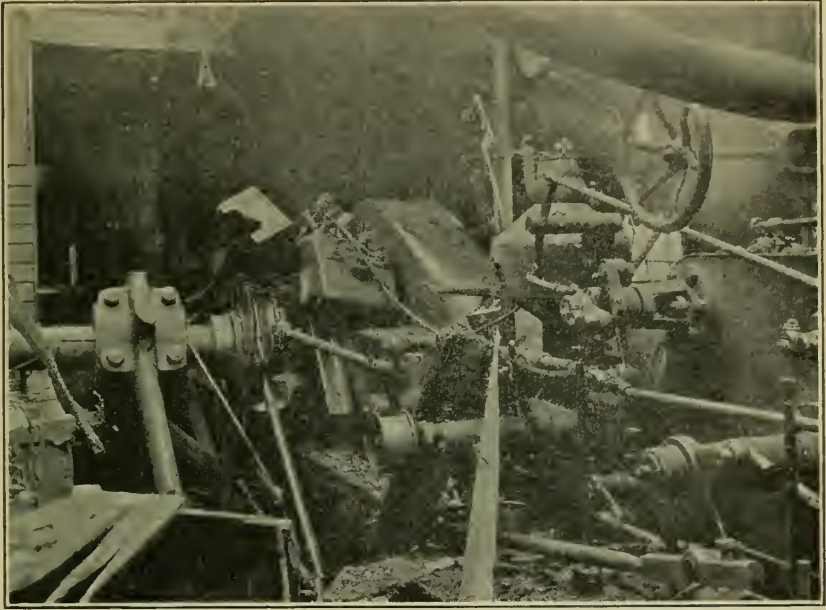
The wheel was fourteen feet in diameter with a face of 36", and was in use on a Corliss-type engine of 350 hp. Circumstances seem to warrant the belief that the wreck was caused by breaking of the main belt and subsequent damaging of the governor mechanism when the broken end of the belt whipped around and struck it. Immediately prior to the wreck plant lights went out, apparently indicating that the generator, driven by the engine through a jack shaft and pulley from the main shaft, had stopped.

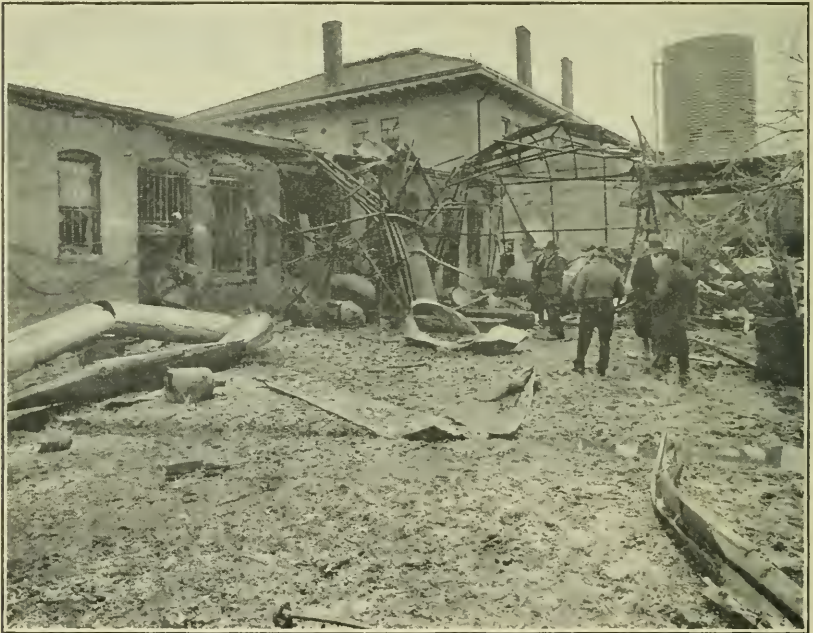
Purchased second-hand about five months previous to the accident, the boiler had a patch 36 inches wide running along the bottom of the shell from head to head. This patch was secured by electric welding, and in the explosion both longitudinal welded seams were torn apart for their entire length. The shell itself was hurled about 150 feet into

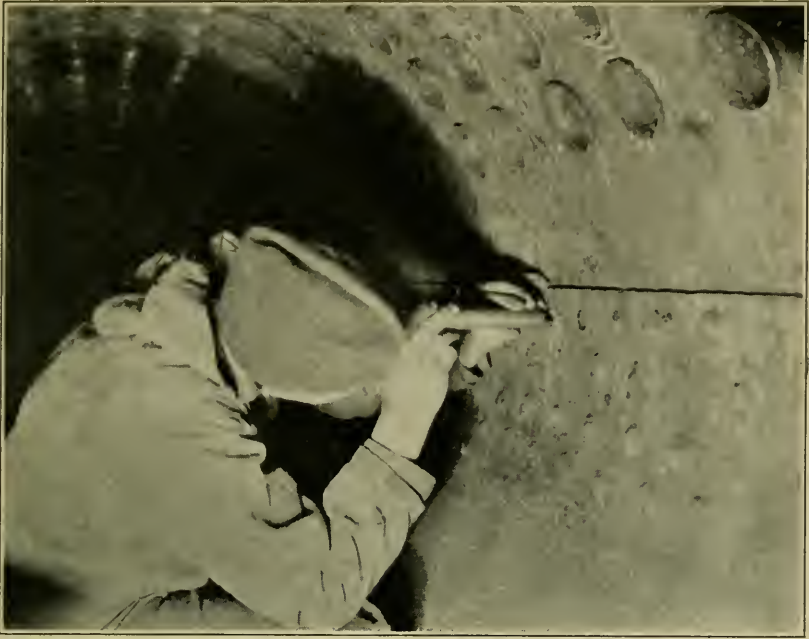
*Figure 3*

*After seam leakage or the snapping off of a rivet head under the inspector's hammer has given evidence of the presence of caustic action, a close examination of the rivet hole wall through the Hartford Periscope frequently results in the finding of cracks so small as to be invisible to the naked eye.*

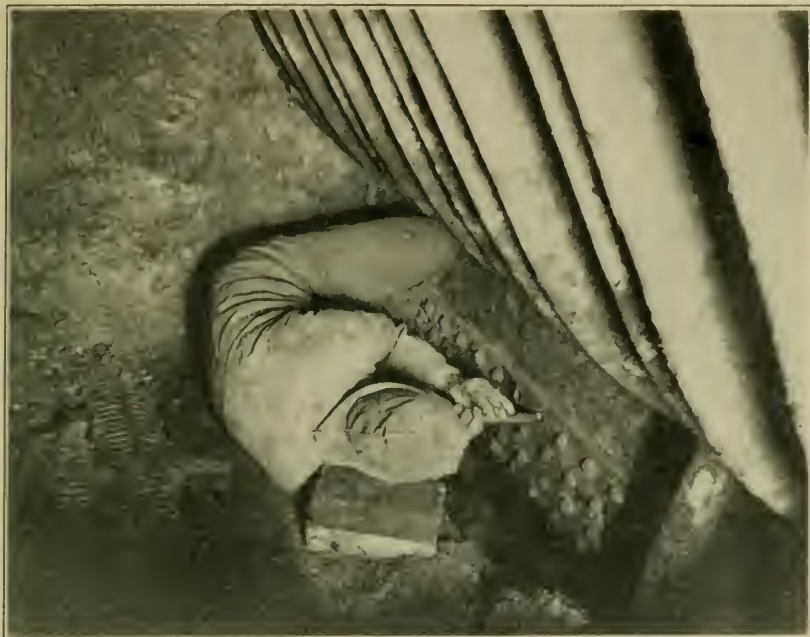
Figure 4

*The periscope in use by an inspector on the mud drum of a water tube boiler. Muriatic acid and fine emery cloth are used to polish the hole so that, to the naked eye, its surface appears bright and smooth.*

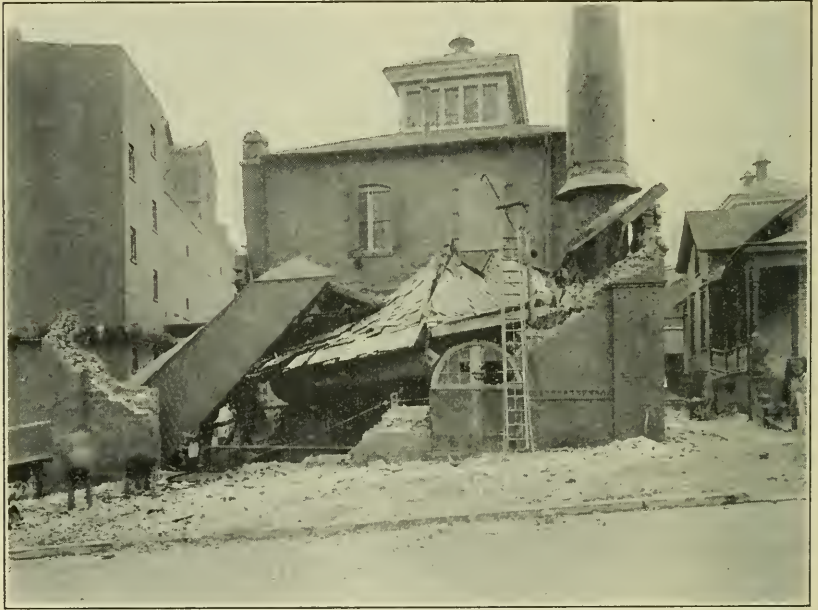
Although the building housing the boilers was practically destroyed, and all piping was torn down, only one of the three horizontal tubular boilers was damaged. That one sustained a dent when struck by a heavy timber.

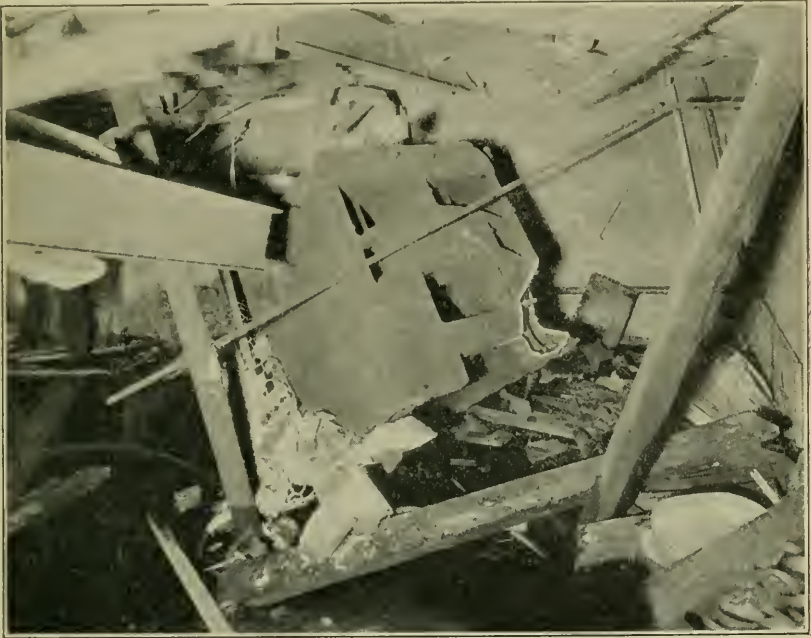
*Figure 2*

Aside from extensive damage to the marble stairway, shown in Figure 1, ironwork of the elevator shaft was bent, a large plate glass window was blown out of the bank, and several door frames and smaller windows were broken. Effects of the concussion were found as high

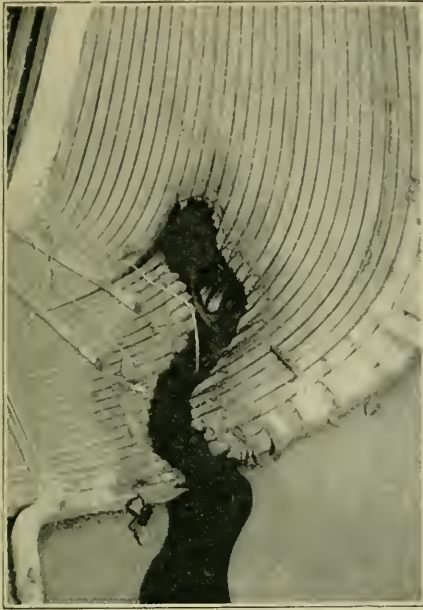
*Figure 2*

Figure 2 shows the damage done to a high tension coil in a 10,000 kv-a. transformer. Evidently the stroke of lightning was direct and near the transformer bank, for as a large amount of copper from several turns of this coil was destroyed and a number of other coils were seriously damaged.

It is highly improbable that any type of lightning arrester now being built would have prevented either of these failures, although experience seems to show clearly that in a vast majority of cases where suitable lightning arrester equipment is correctly installed, proper functioning of the arrestors and the safeguarding of the protected apparatus, should be expected.

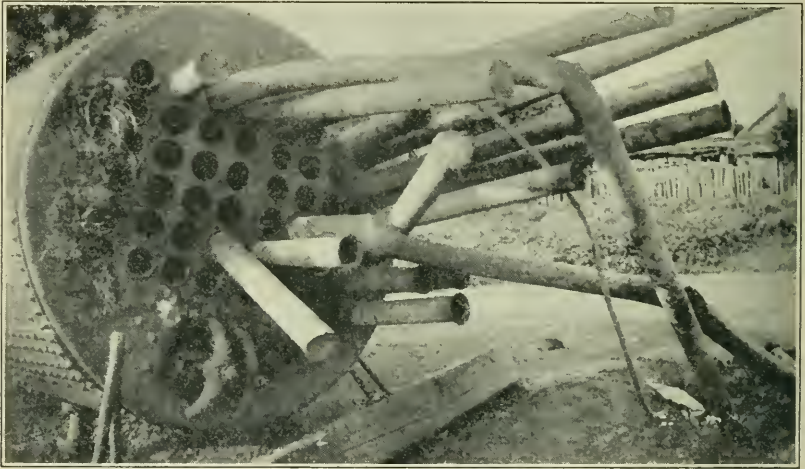
UNUSUAL, in some respects, was a recent accident at an Alabama planing mill where several tubes of a horizontal tubular boiler lost their grip in the front tube sheet and were blown entirely out of the boiler. It was said that some of the tubes had not been beaded and that on others the work had been done improperly. Two men were killed, the boiler house wrecked, and part of the mill damaged.

The accident occurred in the morning before the mill machinery was started up. There was little doubt that considerable over-pressure was present, even though the explosion ruptured neither the shell nor the tube sheets. When the front sheet bulged, after pulling away from three through stays and breaking another, the tubes pulled out and allowed steam and hot water to escape through the tube holes with terrific force. The two victims were caught in the path of this scalding flood and their bodies hurled 200 feet. Reaction shot the boiler backward about a hundred yards.

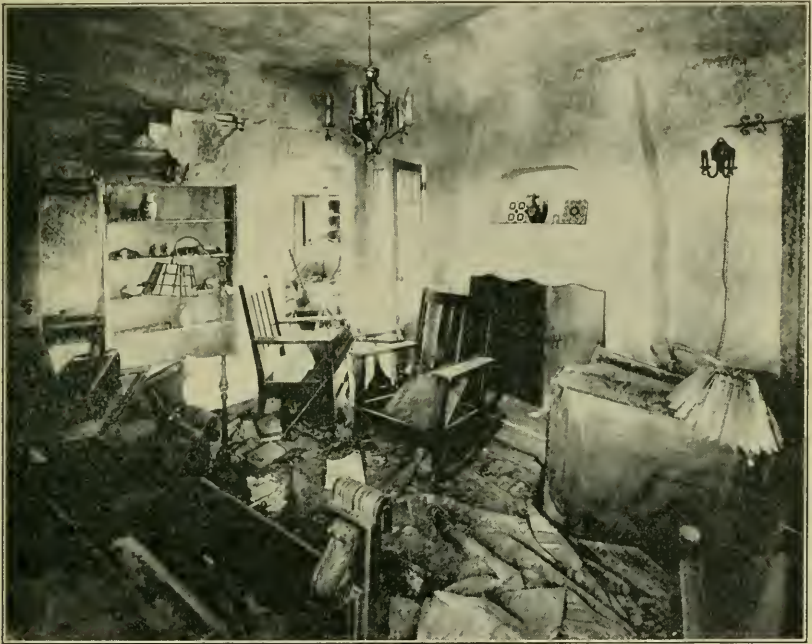
THE accompanying illustration shows only part of the damage caused on May 20th when a hot water supply tank exploded in a residence at El Paso, Texas. Tearing out of the lower head allowed the vessel to shoot upward through two floors and pass out through the roof. When it descended it pierced the roof of a house across the street, crushed a bed, and splintered the bedroom floor.

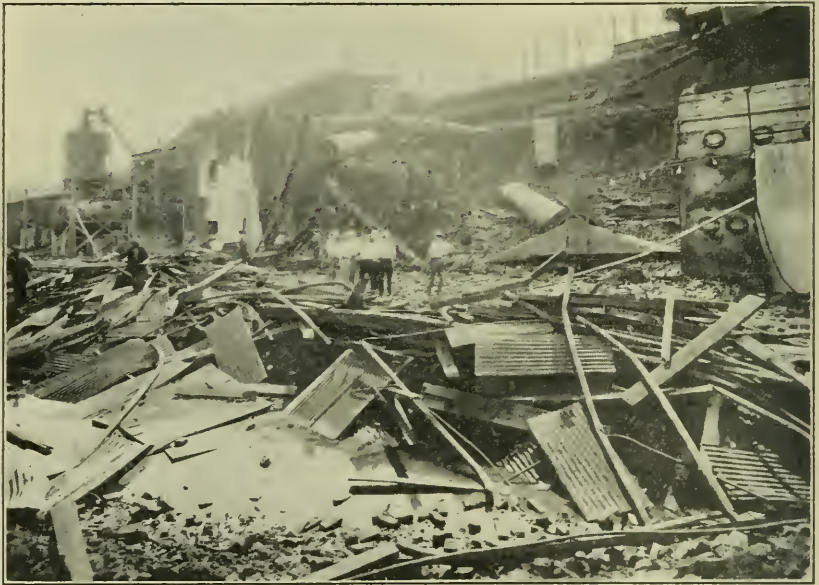
*Figure 1*

CHOOSING the very moment on the afternoon of July 29th when hundreds of workmen, right hands upraised, were reciting their impressive daily pledge to preserve safety, a terrific boiler explosion killed two employees and seriously injured five others at the

Clarksburg, W. Va., tin plate mill of the Weirton Steel Company.

The initial failure consisted of the blowing out of the plain or solid head in the mud-drum of Boiler No. 4, as shown in Figure 2. This boiler and Boiler No. 3 were each of 350 horsepower rating and were placed together in a single setting. In a row with them were five newer 500-

The style of setting used for the smaller boilers was such that the plain heads of their mud-drums were enclosed in masonry and were inaccessible for exterior inspection. An accumulation of soot, ashes, and moisture in the narrow space between the setting and the head that failed had led to considerable external corrosion, and the weak-

ening thus caused was further aggravated by the obsolete, somewhat flattened design of the head in which breathing action would produce flexing at the sharp turn of the flange.

When the head blew from Boiler No. 4 it drove the mud-drum of Boiler No. 3 endwise in such a way that tubes of the rear bank pulled loose and the reaction of steam and water escaping through the tube holes skyrocketed the rear top drum into an open field several hundred feet away. Boiler No. 5, which stood next to the exploding boiler on the other side, was swept from its setting and damaged beyond repair. Fortunately, it was not under pressure at the time.

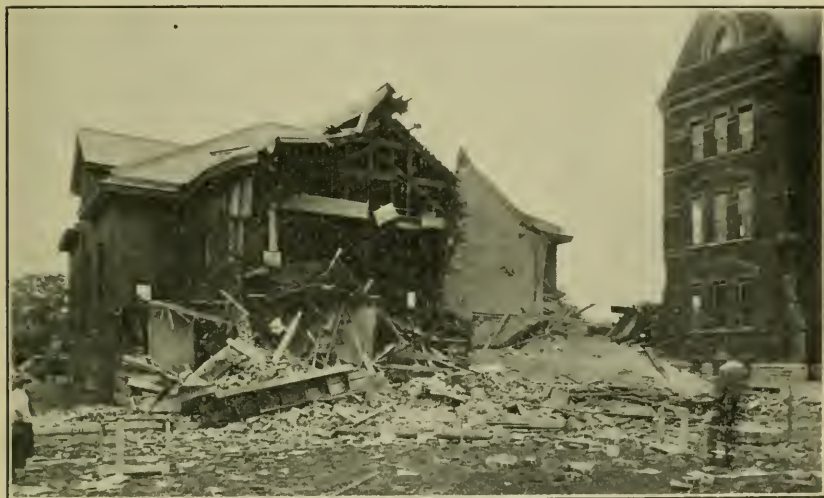
*Figure 1*

The gymnasium of the Gerstmeyer School, Terra Haute, Ind., was damaged to the extent of about \$10,000 on May 27 when a tank used to supply hot water for shower baths exploded with extreme violence. One head of the tank emerged from the building and landed 200 feet away, while the shell burst through a wall and came to rest 80 feet from its starting point. Figure 1 shows the extent to which a side of the building was damaged.

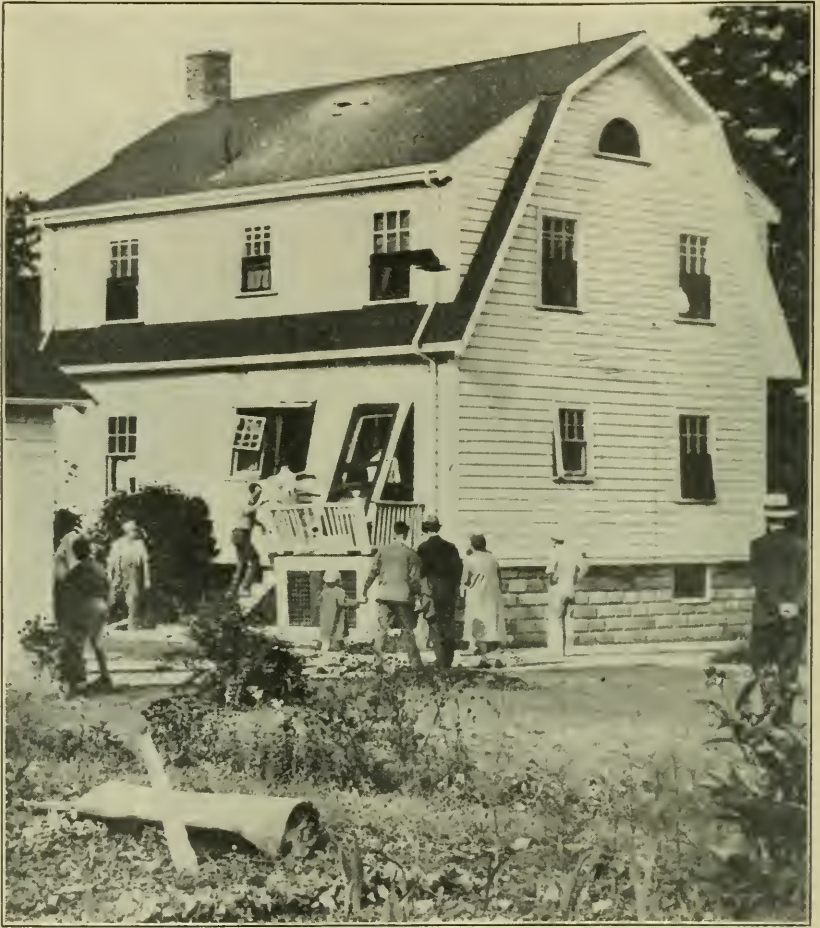
*Figure 2*

Mr. and Mrs. C. D. Collins of Watertown, Mass., were asleep in the second story of their comparatively new \$10,000 home on the night of July 11 when a hot water supply tank in the kitchen below them exploded. passed upward within ten feet of their bed, and went out through the roof. The concussion bulged outside walls, buckled floors, and weakened the frame structure so seriously that, in the opinion of builders, there was doubt whether it would be cheaper to attempt repairs than to erect a new house. Persons in nearby houses were hurled from their beds by the force of the blast and a policeman who was standing within fifty feet of the Collins home was thrown from his feet.

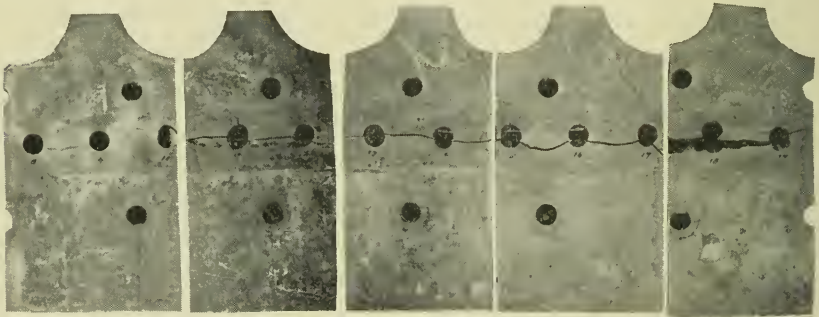
Figure 1

THE encountering of caustic embrittlement recently in two large batteries of water-tube boilers located in regions where this kind of boiler trouble had not previously made its appearance should impress on plant men the importance not only of avoiding the use of feed-water treating methods that are capable of producing water of improper sulphate-carbonate ratio, but of reporting at once to plant officials or the insurance company the finding of broken rivet-heads and leaks at riveted joints.

At one plant in the western part of New York state the drums of seven boilers of the Babcock and Wilcox cross-drum type were affected

so extensively that their continued use would have been dangerous. At another plant, located in Utah, six out of a battery of 14 boilers of the Stirling type had to be taken out of service.

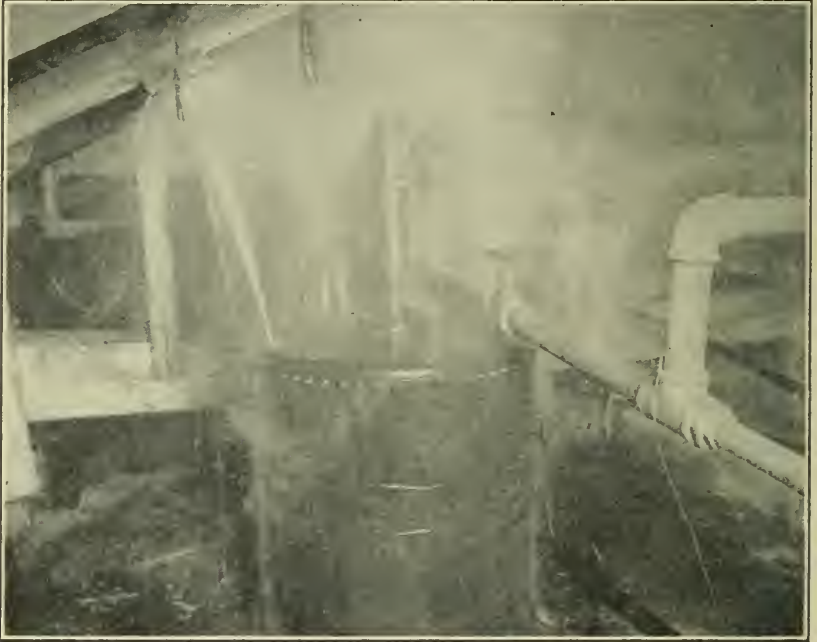
*Figure 1*

At another plant where there were eight water-tube boilers of the Stirling type set in pairs, the clue that led to the inspector's discovery of a serious condition was the finding of water in the inboard ends of

the upper drums of one of the boilers. This indicated that the drums had sagged down and led him to suspect that the supporting "I" beam between the boilers had either been warped by exposure to furnace heat or had deteriorated otherwise, a condition that could be expected to place an excessive strain on some of the blank drum heads to which supporting lugs were attached. Such proved to be the case, for the lugs of the middle drum blank heads were entirely clear of the beam, thus throwing all the inboard weight on the blank heads of the front and rear drums. Brickwork prevented an examination of the outer surfaces of the heads but by digging through a layer of hard scale inside the boiler the inspector uncovered an 18-inch crack along the turn of the flange beneath the lug of the blank head of the rear drum. The

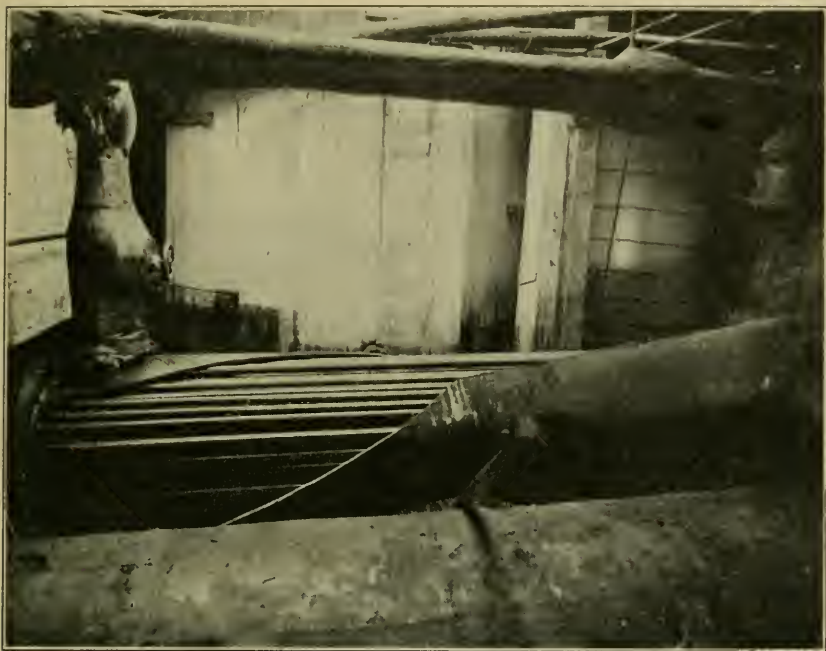
**A**N OPERATOR at a large storage plant in Missouri was in the act of starting the brine circulating pump of a compression refrigerating system on the afternoon of October 23, 1930, when the shell of a brine cooler near which he was standing exploded and injured him so severely that he lived but a few minutes. Two other men who were present in the room were badly burned by the release of approximately two and a half tons of liquid ammonia. Their rescue was effected with the greatest difficulty by other employes who had to contend not only with suffocating fumes but with an explosion of ammonia vapor that became ignited, it was thought, by sparks from electrical equipment. Machinery in the compressor room was badly damaged by the blast which carried away part of the roof over the exploded tank and hurled down several doors. The loss from direct damage, amounting to \$8,760, was covered by insurance in the Hartford Steam Boiler Inspection and Insurance Company.

The brine cooler, which had been in use about twelve years, had a shell 42 inches in diameter and 16 feet long. Gas welding had been used in forming the longitudinal and girth seams, as well as for joining the ends of the shell to the cast steel tube sheets. Failure occurred by the tearing apart of one of the longitudinal seams, the break following along the seam for several feet before changing direction and going into the solid plate, as shown in the illustration. It was plainly evident that the welding had been poorly done. In fact, test coupons taken from another part of the seam after the accident were so weak at the point

of welding that they broke while under the slight pressure necessary to straighten them before they could be put into the tensile testing machine.

Because it was strongly suspected that the welded seams in several other vessels of the same age and make were in as poor condition as those of the exploded tank, the owners decided to replace them with others having riveted seams.

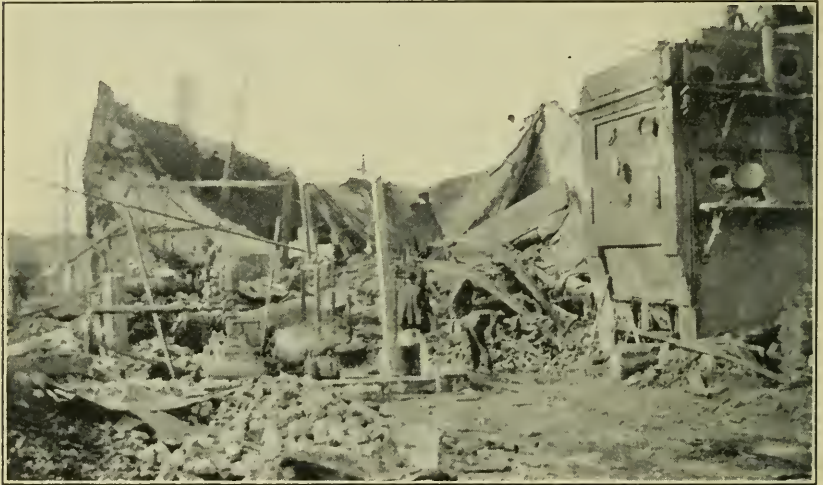
*Figure 1*

## Disastrous Explosion Results *from* Corrosion of Blind Head That Was Buried *in the* Setting

CORROSION that had taken place unobserved behind the masonry in which the blind head of a mud drum was buried caused the explosion of a water tube boiler at a municipal light and pumping plant on the night of April 5. Three men were killed

and three were injured. The fireman, his brother, and another workman were the ones who lost their lives; the injured were unemployed men who were in the boiler room in search of work.

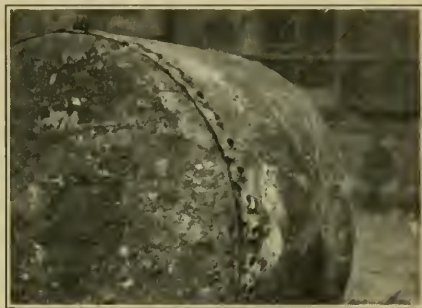
*Figure 2*

Figure 2 is a picture of a boiler drum that had been wasted so seriously that an explosion would certainly have resulted had it been continued in service. An inspector discovered the condition at the time the boiler was offered to this Company for insurance. It will be noted

that the end of the shell plate had thinned down to little more than cardboard thickness. The head itself was likewise wasted and had cracked near the turn of the flange

In order that mud drum heads may be readily accessible for inspection and that there may be less opportunity for the accumulation of ash around the heads, this Company recommends the use of either a furnace wall division plate as illustrated in Figure 3 or else some similar arrangement. This plate may be made of cast iron, or of plate steel at least  $\frac{1}{4}$ " thick reinforced with angle irons. Not only are these division plates urged for all new installations, but it is strongly recommended that they be installed in the settings of boilers now in use where heads are covered by masonry. The expense of altering the setting is not great, and is more than justified in the interest of safety.

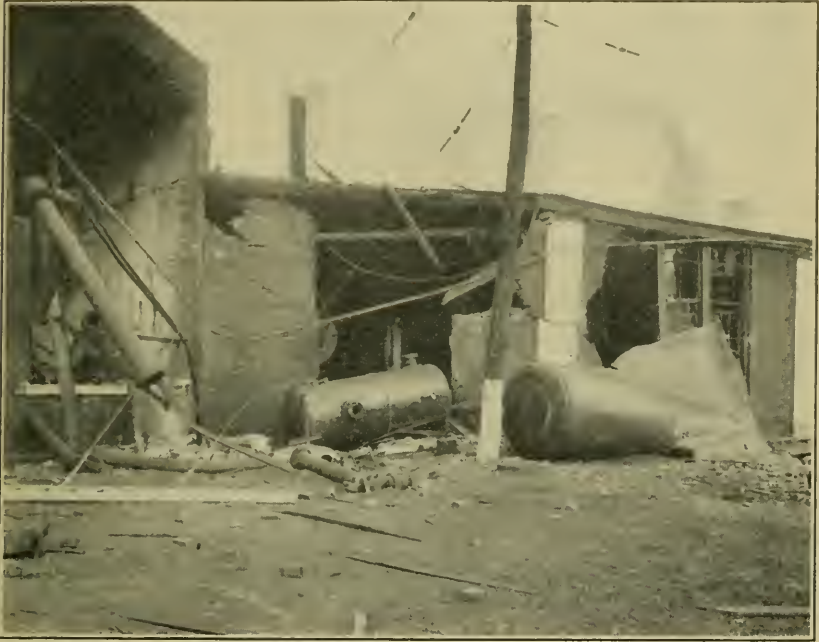
An investigation after the accident revealed that one of the steel strips in the compressor's feather-type discharge valve had broken in two and curled up. From all appearances it had been subjected to great heat, for whereas such strips are made of tempered steel, this one could easily be twisted and bent by hand. It has been demonstrated on many occasions that leaky discharge valves will cause abnormal

heating of the discharge air. The assumption is that this heat is developed by recompression of hot air that leaks back from the line through the valve after the piston has completed its compression stroke and is traveling in the opposite direction. When the temperature reaches

the ignition point of the particular mixture of oil vapor and air in the line at the time, an explosion results.

The extent to which pressure may reduce the temperature necessary to ignite certain mixtures of air and vapor from the various sorts of lubricating oil would seem to be an appropriate subject of laboratory research. In any event the danger of explosions of this nature makes it advisable for every engineer having compressors under his charge to choose lubricating oil with care and to see that oil is not used in excess quantities. The temperature of the discharge air should be watched closely, for the combination of oil vapor, air, and high temperature seems to be a treacherous one.

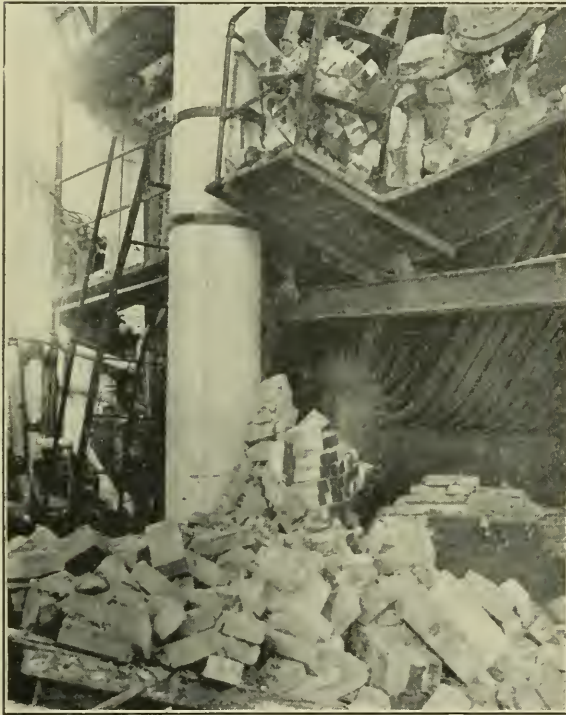
*Figure 1*

The steel columns supporting the boiler and the 18" steel girders between these columns were so badly bent and twisted that an entire new supporting structure had to be installed. Deflection of the support caused the boiler to drop about three inches, breaking the blow-off pipe, the safety valve "Y", and several smaller pipe connections. A companion boiler also was badly damaged, as the explosion

ripped open the breeching and carried away the safety valve. It took thirty-six hours to place the spare boiler in operating condition. Figure 1 shows some of the property damage, which was estimated at \$6,000.

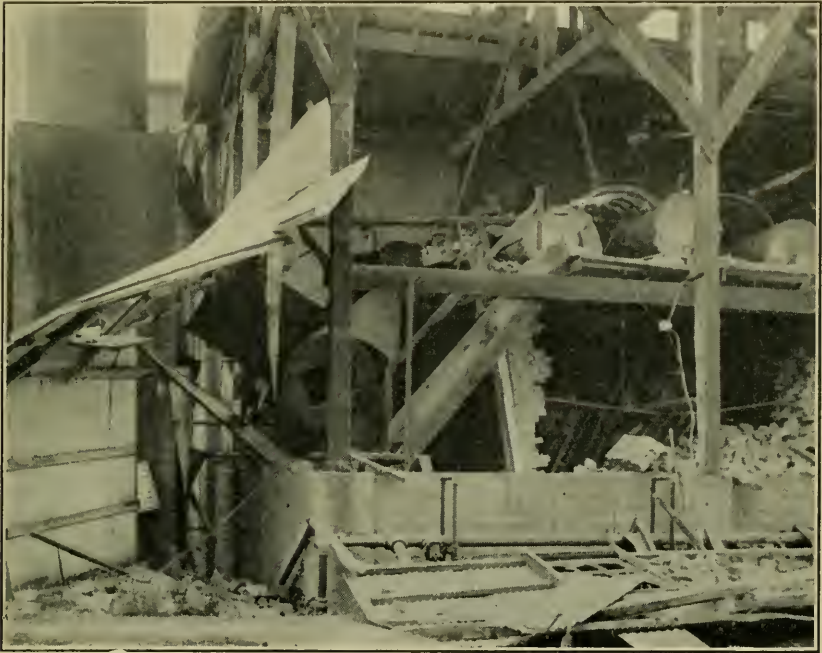
*Figure 2*

July when the engineer of a paper products plant in Los Angeles lost his life. As in the case just described, the breeching was destroyed and the brickwork of the setting knocked down. Caught under the brick wall as it fell, the engineer was crushed. As is indicated by the illustration shown in Figure 2, the property damage was considerable. An estimate placed the plant's financial loss at \$10,000.

It was thought that perhaps the accident was caused by the engineer permitting the gas pilot to flow too long before igniting it, but as the victim was alone in the boiler room at the time this supposition could not be checked. It seems more probable, however, that there may have been a leak in the gas or oil lines that resulted in the furnace filling up with combustible vapor, as in the case previously described.

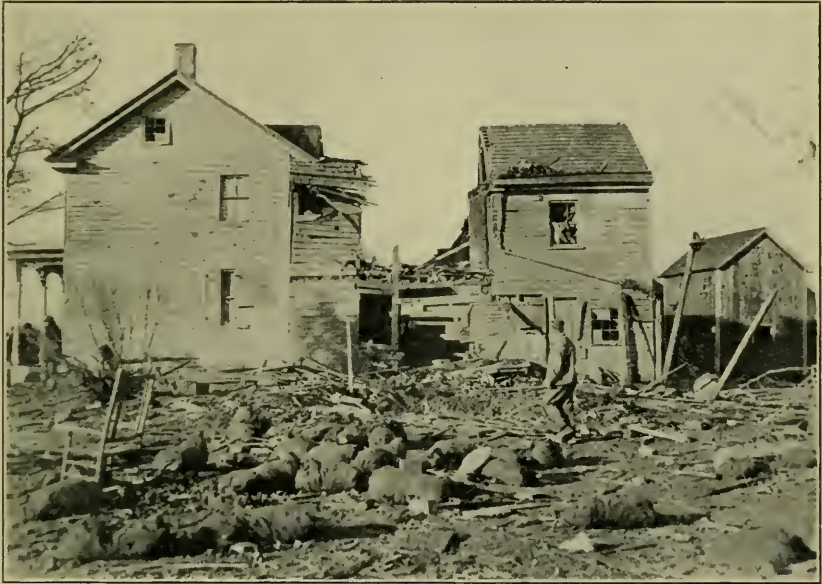
Investigators had no difficulty in agreeing on the cause of the accident. A large steel heating boiler of the firebox type, intended for a pressure of not more than 15 pounds, had been used to furnish steam for two stills at a pressure of from 60 to 80 pounds per square inch. At the time of the accident the pressure may have been even greater, for although the boiler had a steam gage on which pressures up to 200 pounds could be read, there was not a sign of a safety valve. It seemed evident that the persons responsible for the installation had little knowledge of boilers.

Even though its speed must have been checked when it encountered the house, the boiler traveled 500 feet before coming to rest. The shell was found intact, but the furnace sheet and front head had been torn out completely, stripping the staybolt threads.

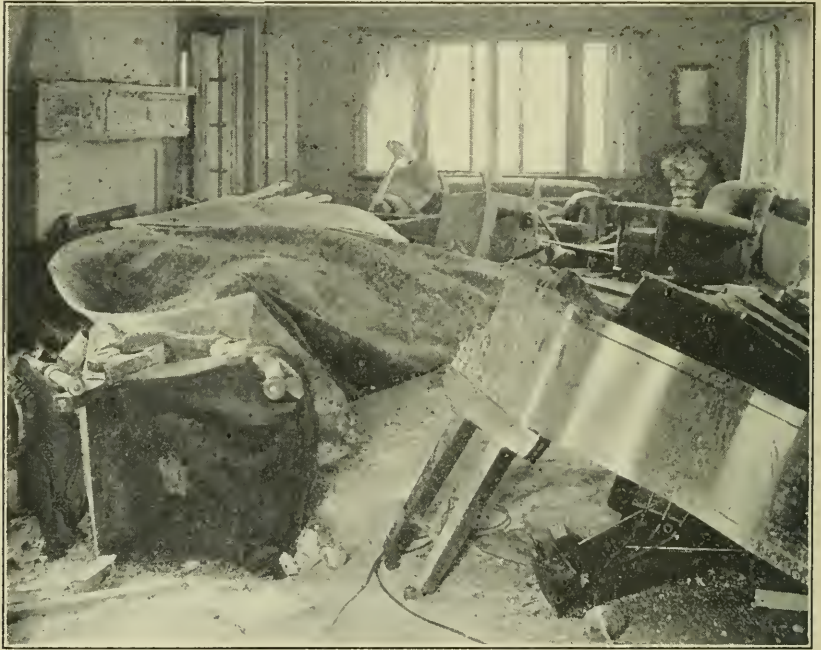
*Figure 1*

**T**WENTY-FOUR guests at a Halloween party in Sidney, Ohio, had narrow escapes from injury when a cast iron heating boiler exploded a few minutes after they had left the home of their hosts, causing damage to the house and furnishings estimated at \$22,000. The boiler stood directly beneath the living room in which the guests had been seated. Figure 1 shows the room as it appeared after the

blast. A nursemaid and a baby who were asleep on the second floor were not injured, although ensuing fire threatened to block their escape from the building.

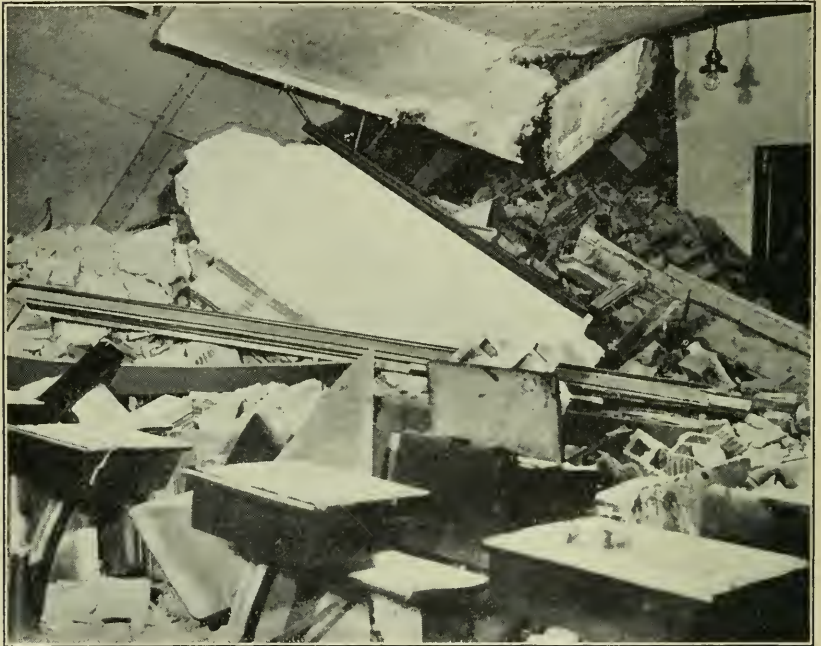
*Figure 3*

as an exploding hot water tank wrecked the interior of an expensive home. The concussion was so severe that the occupants of a neighboring house were thrown from their beds. In the house in which the explosion occurred walls were cracked, floors were bulged, and the windows as well as doors were torn from their fastenings. Property damage was estimated at \$7,500.

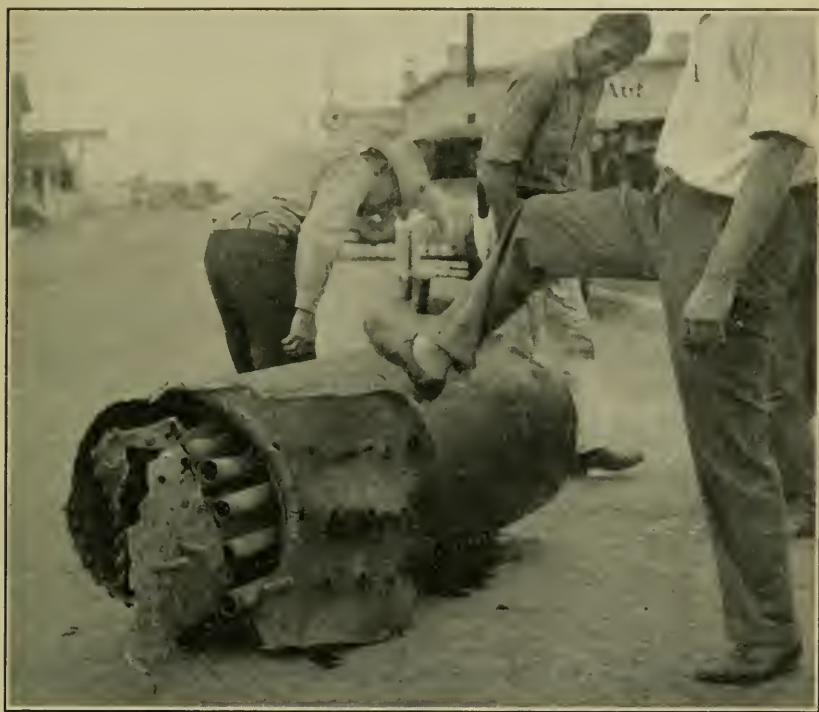
*Figure 2*

A safety valve in which the spring had not been screwed down but which in another way had been made just as ineffective as the one mentioned above, figured in still another laundry explosion that occurred a few weeks ago in Texas. In this case the safety valve had been installed with a stop valve between it and the boiler. The owner intended,

of course, that this valve should be kept open. In some way it became closed with the result that the locomotive-type boiler dropped its crown sheet, tore in two at the throat sheet, and traveled abruptly up the main street of the town. The barrel, shown in Figure 2, shot forward 300 feet to cut down two gasoline pumps in front of a filling station. The firebox end was hurled backward against a telephone pole. Nothing was left of the boiler house.

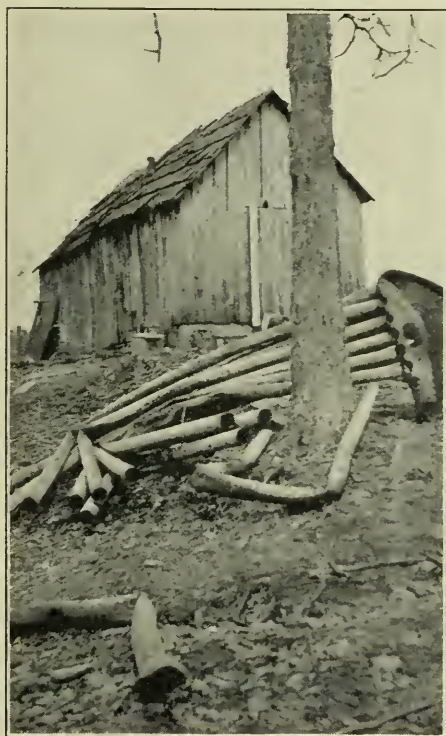
*Figure 1*

At one plant, a sawmill in a Southern state, a horizontal tubular boiler 36 inches in diameter and 12 feet long failed at the longitudinal seam of the front course on the morning of March 10. This sheet tore away from the front head and second course, crashing into and demolishing a mill building. The two other courses, together with the rear head, sailed like a rocket over another building and came to rest in a copse of wood 900 feet from the starting point. With the tubes still attached to it, the front head was driven against a tree with such terrific force that some of the tubes were bent almost double, as shown in Figure 1. Had the tree not been there, these parts of the boiler would have plunged into the residence of one of the mill workmen. One tube did break away

The grooving along the seam that failed was so deep that an inspector who examined the plate after the accident was inclined to believe that the explosion occurred at the ordinary working pressure of the boiler. The fireman had brought the pressure up and was in the act of rolling the engine off center, preparatory to starting the mill for the day's run, when the accident took place. Three men were killed

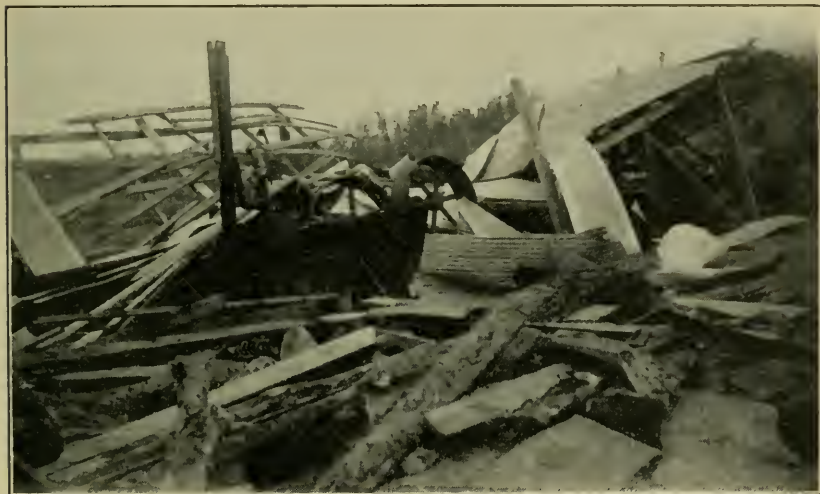
*Figure 2*

A boiler of the locomotive firebox type figured in another recent explosion at a sawmill in the South. The mill had been working at a new location only two days when, while workmen were preparing to start operations on the morning of January 12, the boiler blew up and

killed two men who were firing it. Failure took place along the inside lap of the course nearest the firebox, and was caused by a groove along the inside lap so deep that at some points only a thin film of sound metal remained.

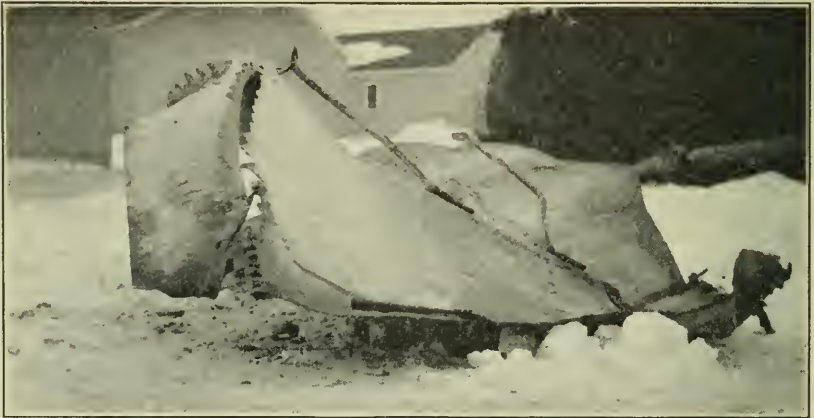
*Figure 3*

The initial break occurred along the outside surface of the inside sheet forming the double riveted lap-seam of the front course, shown in Figure 3. After this sheet tore loose it sailed over several plant buildings and came down through the roof of a two-story warehouse 400 feet away. The reaction of escaping steam caused the main portion of the boiler to jump backward about 20 feet to strike the main plant

The plate was judged to have been  $9/32''$  thick originally, and uniform corrosion with some slight pitting had reduced this to  $7/32''$  in some places. There was also a well-defined crack. The edges of the crack were rough and showed signs of considerable exposure. The sound metal remaining at the crack varied from  $1/16''$  to not over  $1/8''$  in thickness.

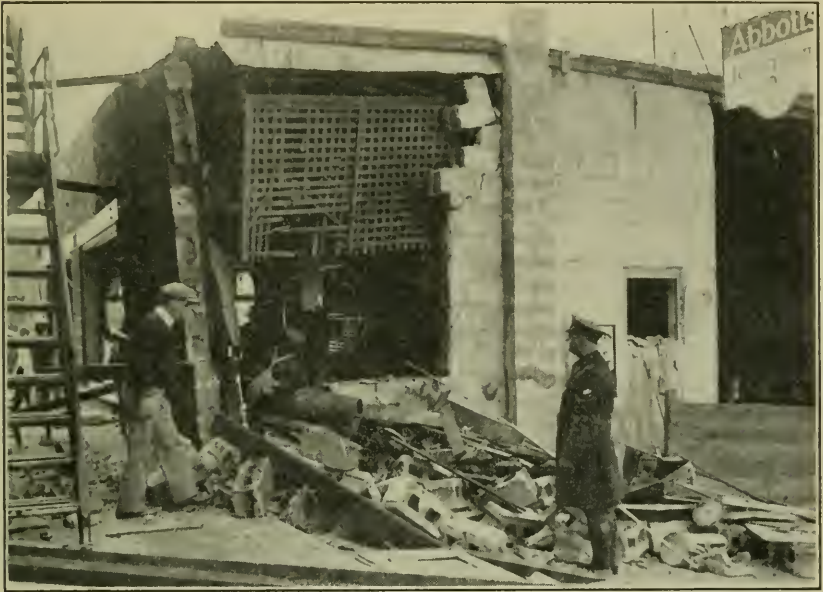
*Figure 1*

The proprietor of a candy shop in Audubon, N. J., was serving a customer a cup of hot chocolate on the afternoon of March 9 when the hot water system heating boiler exploded and hurled both men through a window into the street. Fortunately, the plate glass preceded them by a fraction of a second, so they escaped with minor bruises and cuts. Figure 1 shows the rear of the store. The back wall of concrete blocks was hurled down, and the side wall was tilted outward so as to be in danger of collapse. A newspaper account stated that the property damage amounted to about \$5,000.

Reports indicate that the system was installed without either an expansion tank or a relief valve. Coke was being used as fuel, and as the day was cold and windy it was suspected that the vigorous firing necessary to meet these conditions was too much for the boiler.

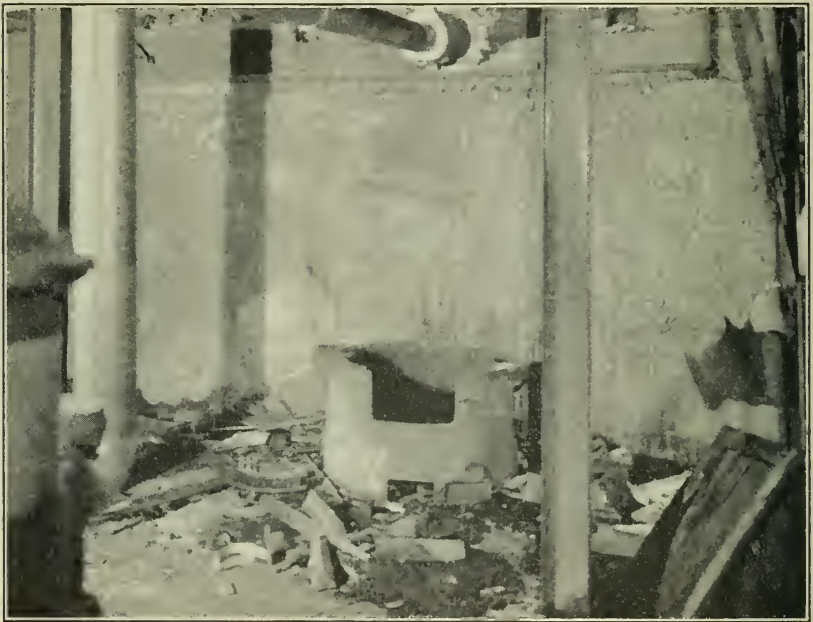
*Figure 2*

Figure 2 shows what was left of the firepot section of a hot water heating boiler that exploded on March 11 in the basement of a pumping plant in Haverhill, Mass. This, too, was a closed system, but one having an air-tight expansion tank and a differential relief valve. The top and third sections of the boiler crashed upward through the first floor, forcing a 12" x 6" beam out of its anchorage in the brickwork, and raising the whole first floor up about three inches. Other parts of the boiler caused considerable damage to the plant switchboard, bending

switch handles, breaking a slate panel, and piercing an iron grill protecting the oil switch. The steel-trussed roof of the building was also raised by the concussion. One of the trusses pulled the brick side-wall about four inches out of perpendicular at the resting place of the truss.

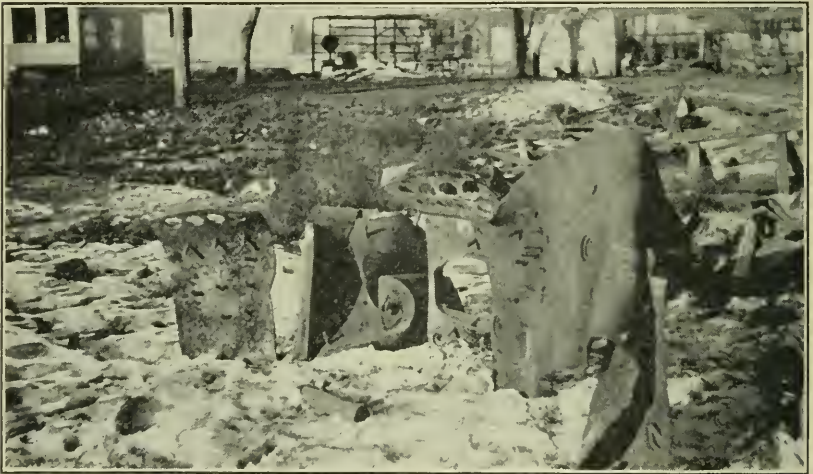
*Figure 4*

In Figure 4 is shown the wreckage of a welded steel hot water supply boiler that exploded January 28, in a building at Yakima, Washington. This boiler was connected to a welded hot water supply tank and neither boiler nor tank was equipped with a relief valve. The day

before the accident the water was shut off from the main in the street. The following morning the engineer fired up the boiler and the explosion occurred three-quarters of an hour later, causing property damage estimated at \$2,000.

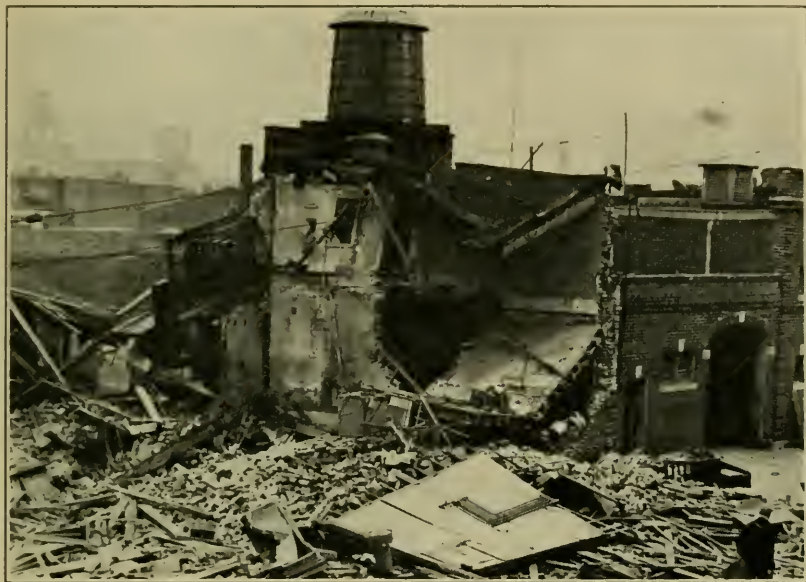
FIGURE 1—A building wrecked when the welded head seam of an ammonia generator failed injuring a man and causing \$15,000 property damage. An illustration of the kind of accident that for years postponed acceptance of welding as reliable for pressure vessel construction.
